# An Archaeological Reappraisal of the Loss of the Nave of the Parish Church of St Mary de Haura, New Shoreham, Sussex

*This dissertation was originally submitted in partial fulfilment  
of the requirements of the Degree of BA Archaeology  
of the University of London in 2004*

*This study is concerned with the archaeology and history of the ruined Norman nave (c. 1130) of the Parish Church of St Mary de Haura, New Shoreham, in West Sussex. It is intended as an up-to-date reappraisal of the lost fabric of the church, through the utilization of a geophysical and structural survey, and the analysis of primary documentary and pictorial sources. It is not, however, a history of the church's complex architectural development, for which reference to other works should be made. It is hoped that this study will advance a greater understanding of the ruined nave, not least through the consideration of its future presentation to the public. The results of this investigation have led to the conclusion that St Mary's nave fell into disrepair around the mid-17th century, and that it was demolished and restructured in the early 18th century. Improved provision for visitors to the site has also

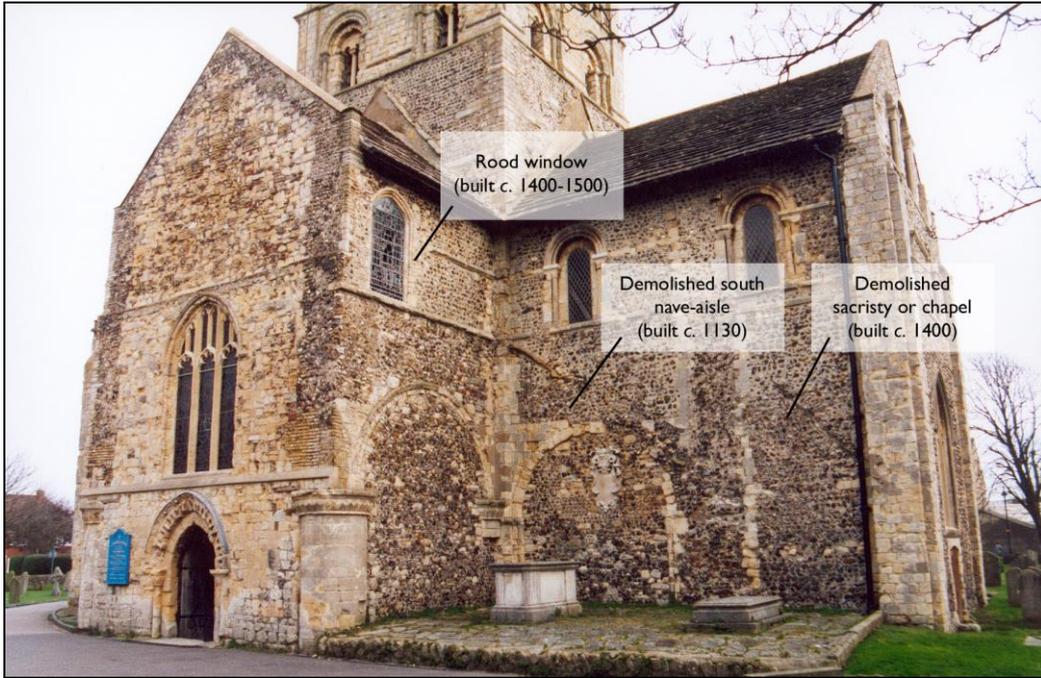
**FIG. 5.1** St Mary's present west front, showing the late Rood window, and the demolished south nave-aisle and sacristy/chapel (Photo: author)

As seen today, the present west front constitutes both Norman and later work [FIG. 5.1]. The original work (c. 1130) consists of the mortared flint walls of the upper arcade and clerestory, the round-headed window in the north clerestory wall, the weatherings of the nave aisles (below the clerestory stringcourse and in the west walls of the transepts), and four round piers, of which the second pair to the west are now, in part, on the exterior of the church (Marshall 1915: 8–10). Following the addition of a sacristy or chapel and a porch to the south nave-aisle around 1400 (see p. 3 above), the latest apparent addition to the nave fabric is a Rood window in the south clerestory wall, dating to around 1400–1500. This window lit a spacious Rood loft in the easternmost nave bay, one end of its Rood beam resting on a stone corbel east of the window base (Simpson 1971: 43, 45; Marshall 1915: 11; Evans 1936: 341–42). This undertaking would have been funded by the parishioners (Friar 2000: 87), and suggests that money was sufficient even after the decline of the port (see p. 2 above), seemingly confirmed by a funerary brass of a mercantile citizen and his wife of c. 1450 in St Mary's chancel (Cheal 1921: 187–88; see also Pilmore 1891: 6; Salmon 1909: 156–57). That new additions were being made to the fabric of the nave, rather than essential repairs, during the 15th or early 16th centuries, strongly suggests that it was still standing and almost certainly complete at that time.

Two main architectural features are present in the west front, those of the entrance doorway and the traceried window above [FIGS 5.1–5.2]. The doorway is effectively undatable in its present position, for although the moulded stone (with beakhead decoration) used in its construction dates to the Norman period, c. 1130, it has been reshaped to form a later, pointed doorway. This may have resulted from too few segments of the original Norman doorway (perhaps that of the west end or south nave-aisle) surviving to make a suitably large round-headed arch, or that a Gothic shape was considered to be more appropriate or appealing at the time of its re-erection (Daniels 1907: 18; Simpson 1971: 41; Evans 1936: 341). This entrance would have replaced the large south porch, by then assumedly also in a state of decay and demolished with the nave (the remaining porch walls appear distinctly uniform, as if systematically razed) [FIGS 2.3–2.4].

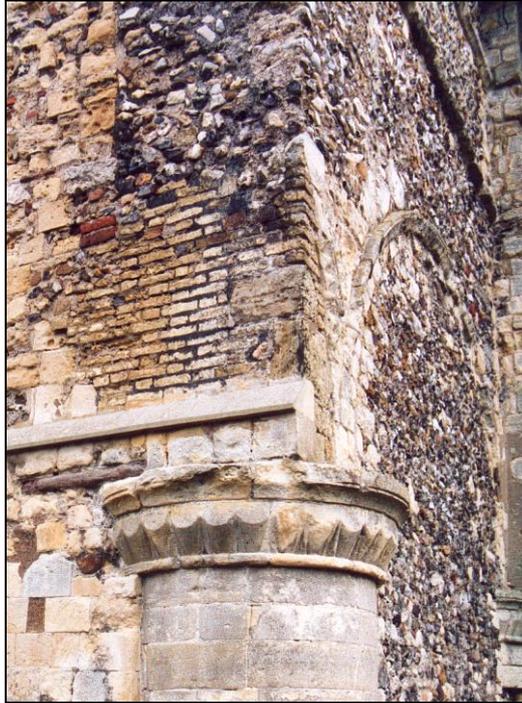
**FIG. 5.4** South-western nave pier arch replaced by bricks (front view)  
(Photo: author)

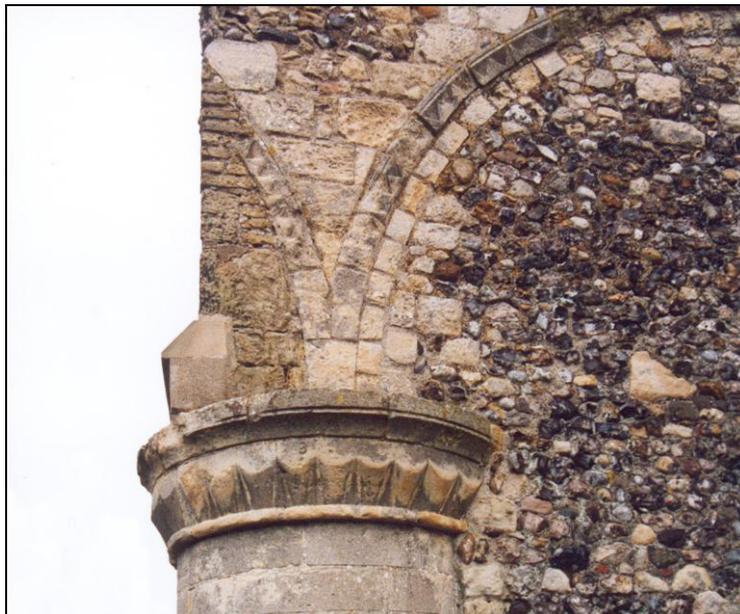
**FIG. 5.5** South-western nave pier arch replaced by bricks (side view)  
(Photo: author)

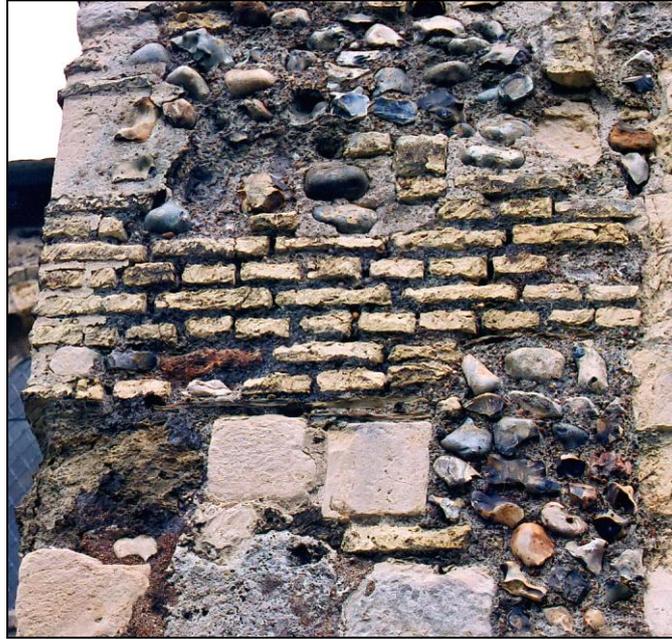
**FIG. 5.6** English bond brickwork over the north-western nave pier  
(Photo: author)

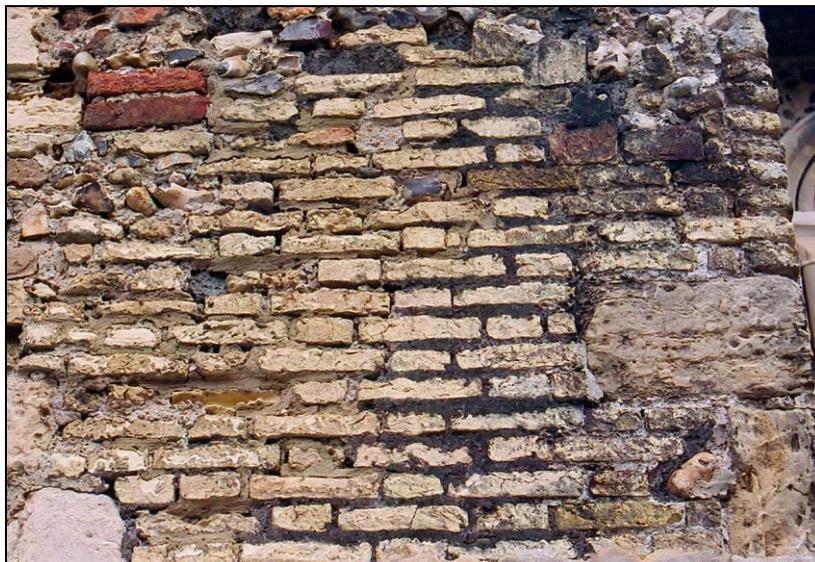
**FIG. 5.7** Flemish bond brickwork (post-1630s) over the south-western nave pier  
(Photo: author)
